The Tributary: *Special Edition*

In This Issue: **The Smooth Rock Lick Project**

BRWA Works to Limit Acidic Mine Seepage into Smooth Rock Lick Run

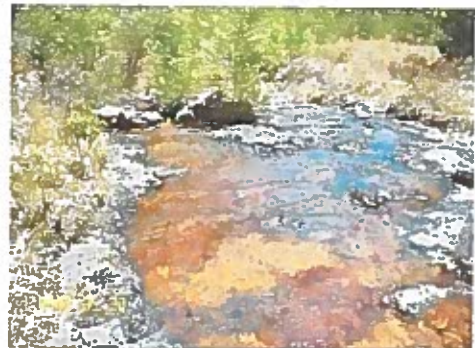
Smooth Rock Lick Site #1 Before Completion of Project

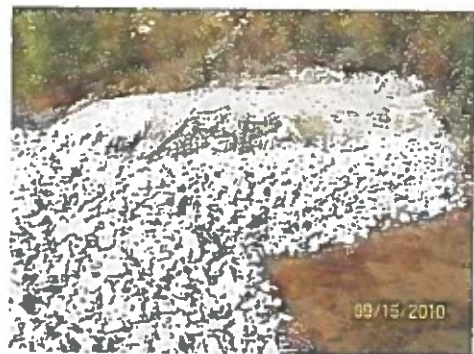
Smooth Rock Lick Site #1 After Completion of Project

The project uses a passive treatment system (no machinery or "dosers" are involved). The basic system consists of limestone channels to convey seeps to limestone leach beds where prolonged contact with limestone will "sweeten" the water by raising the pH and causing precipitation of iron, aluminum, and perhaps some manganese.

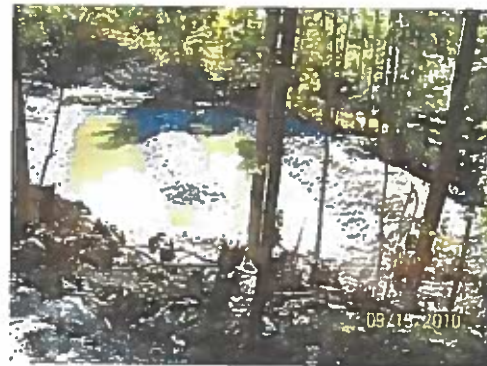
Smooth Rock Lick Site #2 Polishing Pond

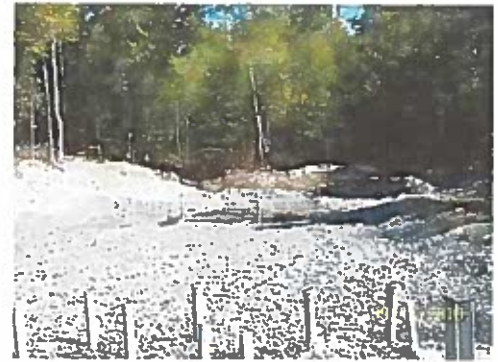
Smooth Rock Lick Site #2 Leach Bed

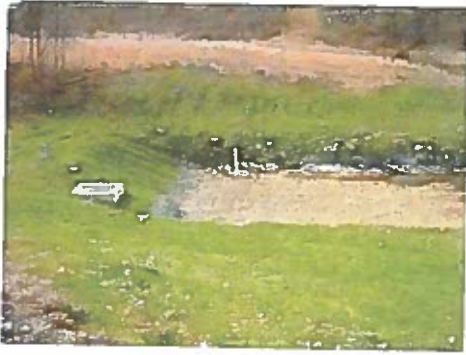
Smooth Rock Lick Site #3 Downstream

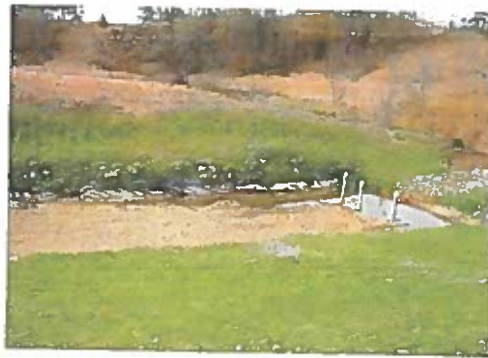
Smooth Rock Lick Site #3 Upstream

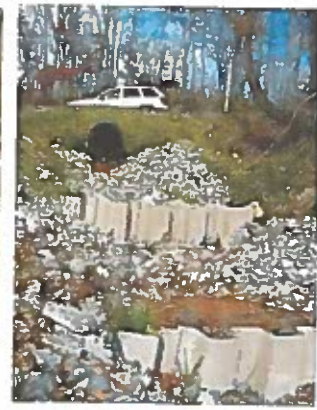
Repaired culvert, part of SRL Project
